Castillo AMA, Aguirre JJC, Borja CB and Cruz AC. 2023. Seismic-induced landslide hazard analysis of the recreational area of the Makiling Botanic Gardens, Los Baños, Laguna, Philippines. *The Palawan Scientist*, 15(2): 69-84. <https://doi.org/10.69721/TPS.J.2023.15.2.07>

Seismic-induced landslide hazard analysis of the recreational area of the Makiling Botanic Gardens, Los Baños, Laguna, Philippines

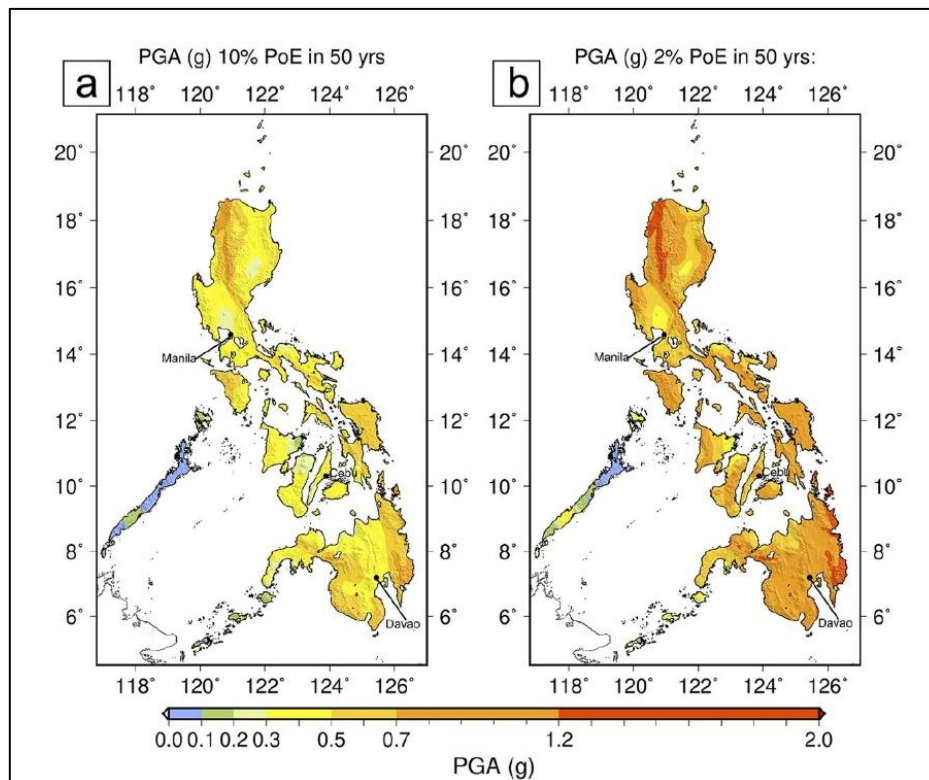
Figure 1. Mean peak ground acceleration (PGA)map for the Philippines with 10% and 2% probability of exceedance in 50 years.

occurrence. Concerning seismic activities, peak ground acceleration (PGA) is the maximum change in speed experienced by a particle in the ground. In contrast, spectral acceleration (SA) is the change in speed experienced by an infrastructure (Bradley 2011). Both PGA and SA may be expressed in *g* or the standard acceleration value due to gravity ($9.81 \text{ m}\cdot\text{s}^{-2}$). Additionally, PGA may serve as a hazard index for short buildings with a maximum of seven stories, on average, in which PGA focuses more on peak ground motion. Meanwhile, SA may serve as a hazard index for tall buildings in which SA focuses more on building behavior. Furthermore, a probabilistic seismic hazard model of the Philippines was generated by the study of Peñarubia et al. (2020). In the study, the Philippine archipelago is defined as tectonically complex and seismically hazardous due to its geographical position and its formations. In the study, a PGA map was generated for the Philippines with a 10% probability of exceedance in a period of 50 years, as shown in Figure 1. For the municipality of Los Baños in the province of Laguna, the PGA for the area ranges from 0.3 *g* to 0.5 *g*. In the case of MBG, a protected sanctuary, a non-intrusive seismic hazard analysis method was preferred to conform with related laws and official memorandums.

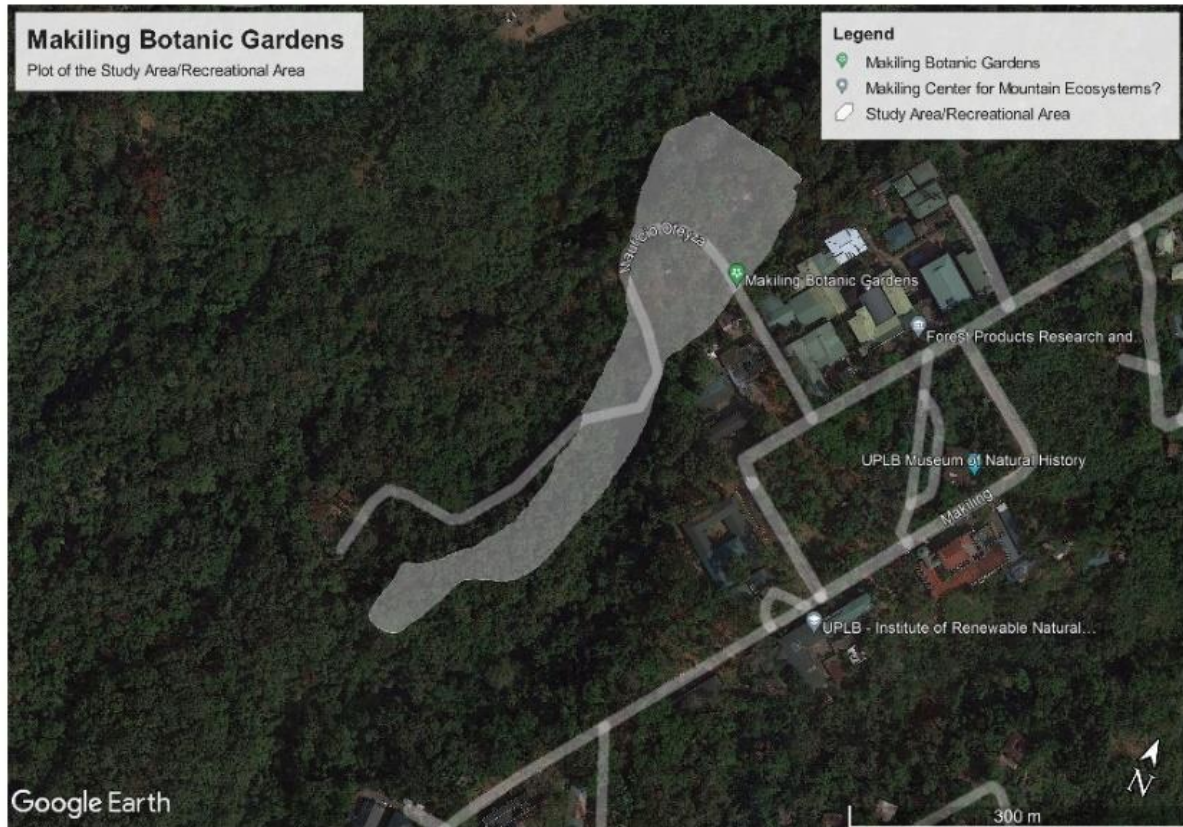
Figure 2. Plot and location of study area.

The study focused only on the 3.5 ha recreational area of MBG, (Figure 2). The area was plotted using WGS84 coordinates and described using maps regarding the local geology and tectonic setting of the MMFR. The MBG has a WGS84 coordinates of 14.1566° North and 121.2342° East. For the procurement of existing pertinent data regarding the

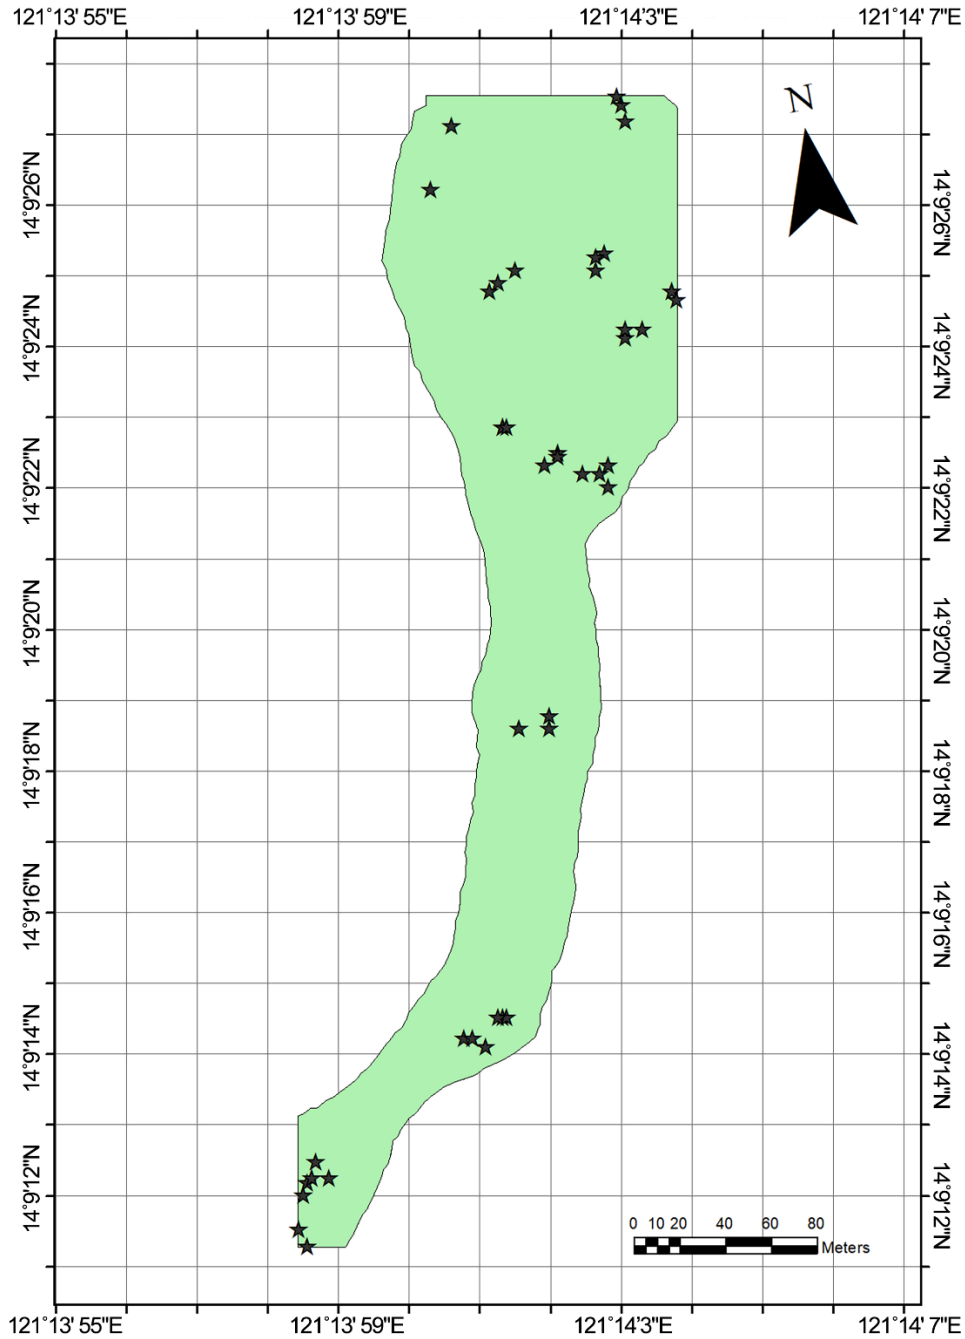
Figure 3. Map of the 3.5-hectare recreational area of Makiling Botanic Gardens showing the sampling sites (★).

A Digital Elevation Model (DEM) from the National Mapping and Resource Information Authority (NAMRIA 2015) for the MMFR ASEAN Heritage Park was provided by MCME, which served as the basis for mapping the elevations and slope angles of the study area in which Figures 9 and 10 show the varying elevations and slope angles present within the area, respectively. At each of the 43 test points, a Dynamic Cone Penetration Test (DCPT) was performed, in which each test point generated a Dynamic Cone Penetration (DCP) n-value profile

(Figure 3). Then, the obtained DCP n-value profile was correlated to shear strength values (Table 1). The shear strength values at each point were then correlated to generate a shear strength map for the study area (Figure 11).

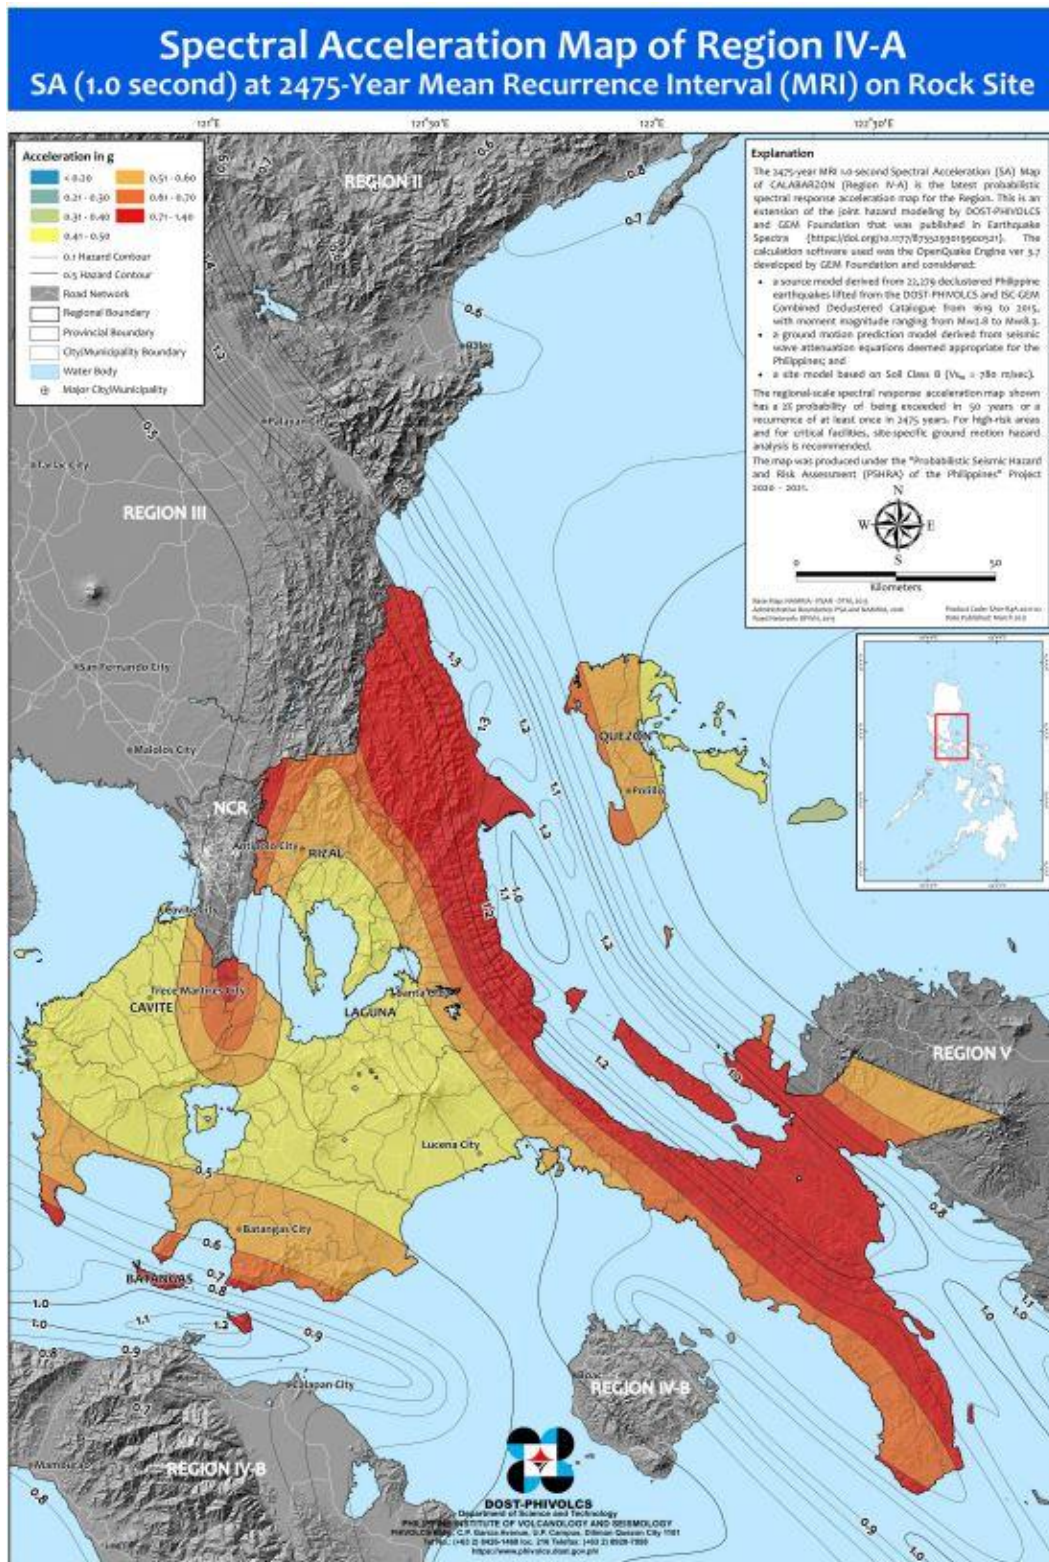
Figure 4. Spectral acceleration map of Region IV-A at 1.0 second.

adopted PGA value was amplified based on the specifications of the American Society of Civil Engineers (ASCE) Section 7-05 and based on the site classification of the study area. Meanwhile, the recreational area of MBG was generated based also on ASCE Section 7-05, a spectral acceleration design response spectrum, with a 475 yr return period. Lastly, the corresponding SA values at each cell of the study area was based from the Spectral Acceleration Maps provided by DOST-PHIVOLCS (Figures 4 and 5).

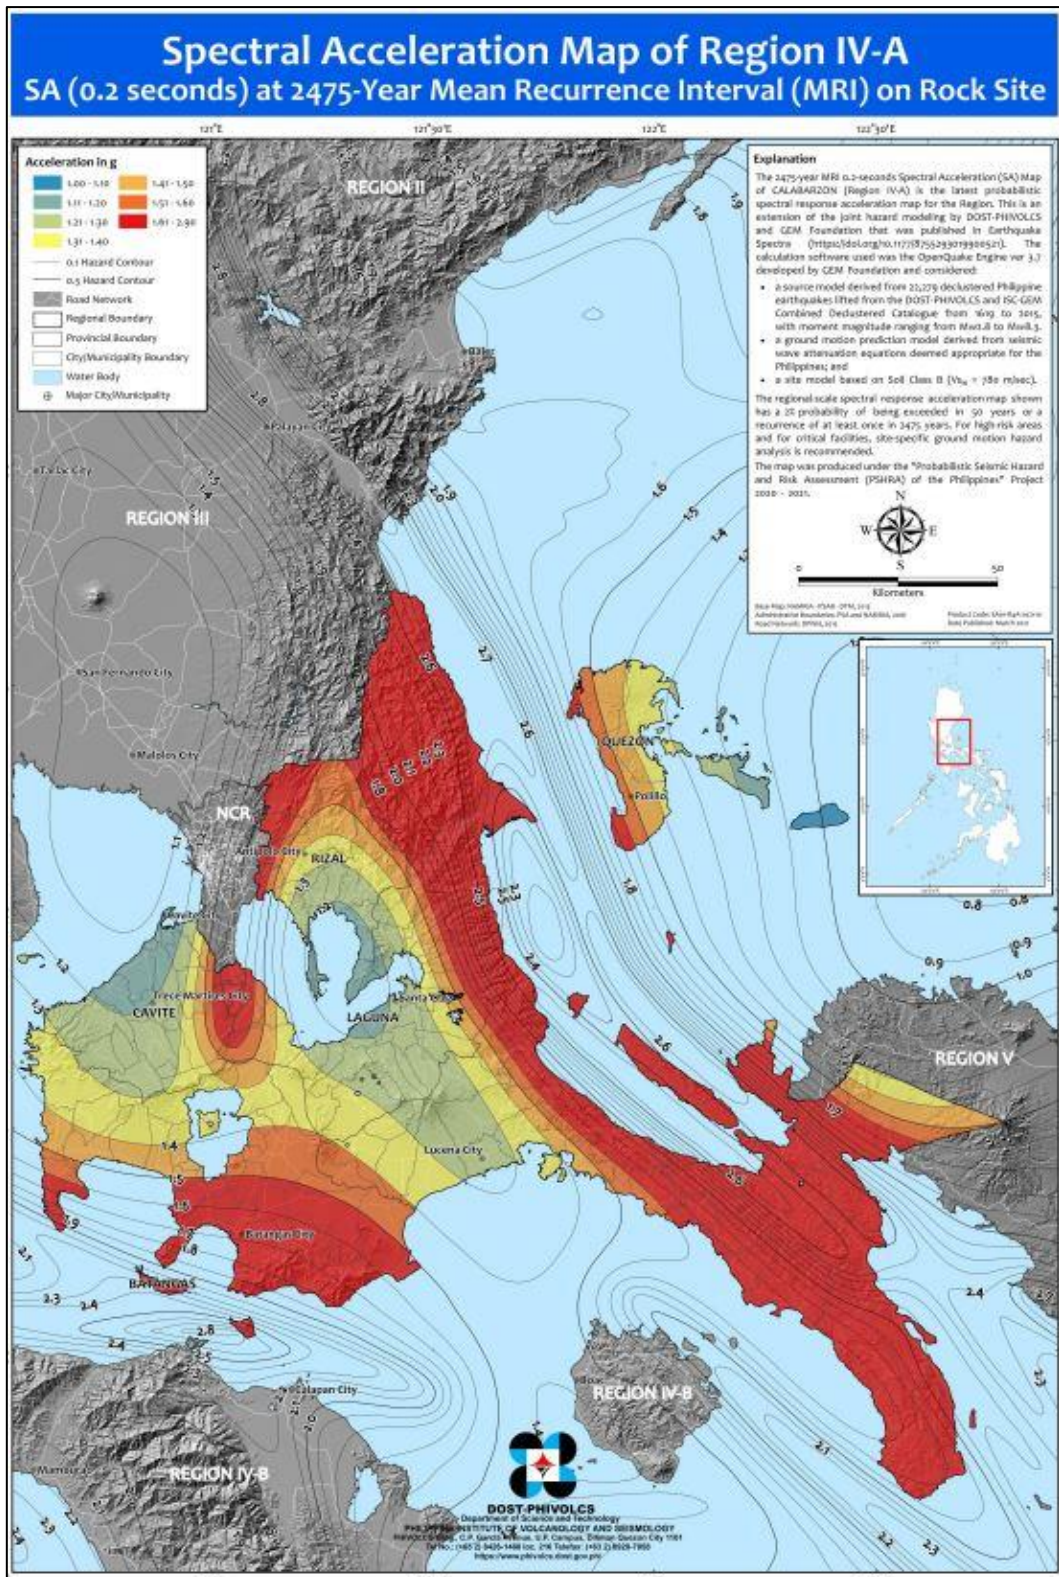
Figure 5. Spectral acceleration map of Region IV-A at 0.2 second.

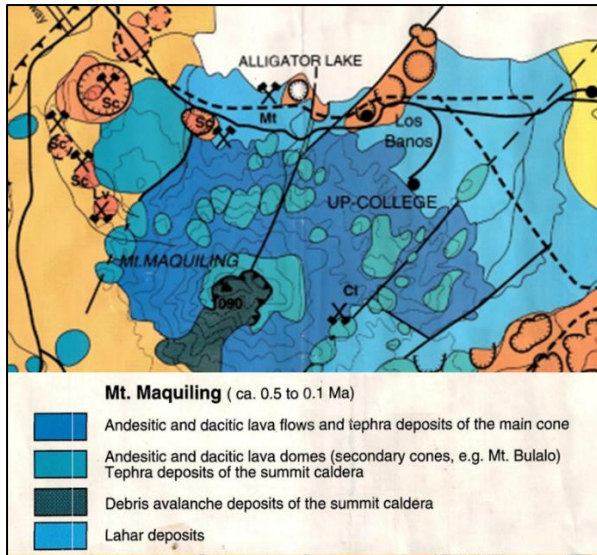
Figure 6. Local geology of Mount Makiling Forest Reserve ASEAN Heritage Park.

Makiling Botanic Gardens (MBG) is an eco-tourism site within the Mount Makiling Forest Reserve (MMFR) ASEAN Heritage Park. Figure 6 shows the local geology of the MMFR ASEAN Heritage Park, which defines the lithology and structures present within the area. To further support the implications of the local geology of the MMFR ASEAN Heritage Park, the presence of a particular type of soil suitable for plant growth and development was considered since

The local geology of the MMFR ASEAN Heritage Park is composed mainly of volcanic materials and residues based on Figure 6. The subsurface material present within the area is part of the Macolod Volcanic Complex, which is composed of volcanoes and volcanic features originating from the Pliocene era (5.3 mya) to the Pleistocene era (11 mya) in which Mount Makiling is part of the said complex (Peña 2008). Moreover, due to the active volcanic processes circulating within the area, tectonic

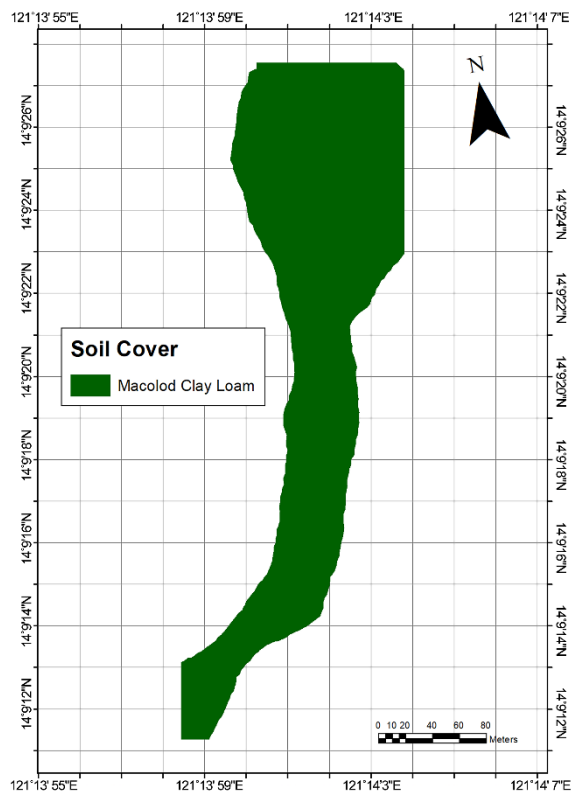
Figure 7. Soil cover map of the recreational area of Makiling Botanic Gardens.

the recreational area of MBG contains a diverse range of flora and fauna. For general visualization of the soil composition of the study area, Figure 7 shows the soil cover map for the recreational area of MBG, which was extracted from MMFR ASEAN Heritage Park soil cover map provided by the Makiling Center for Mountain Ecosystems (MCME). Concerning the soil cover map of the study area, Figure 8 shows the land cover map for the same area extracted from the provided MMFR ASEAN Heritage Park land cover map by MCME.

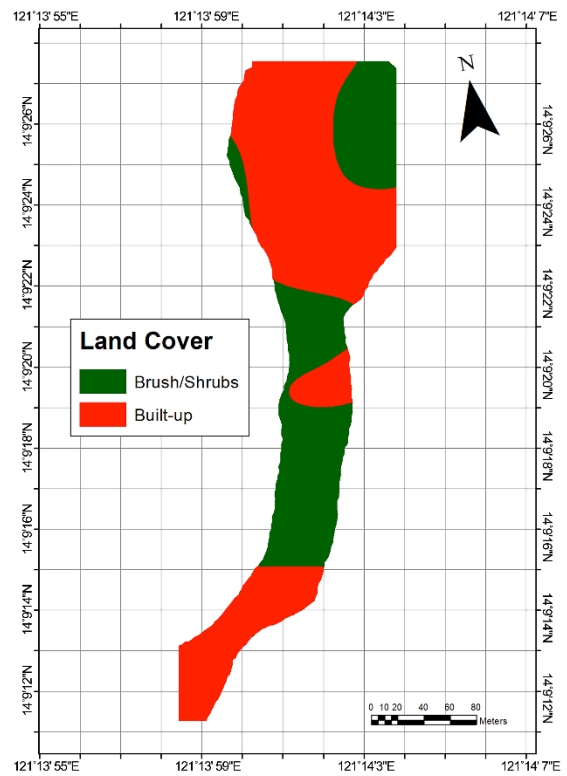
Figure 8. Land cover map of the recreational area of Makiling Botanic Gardens.

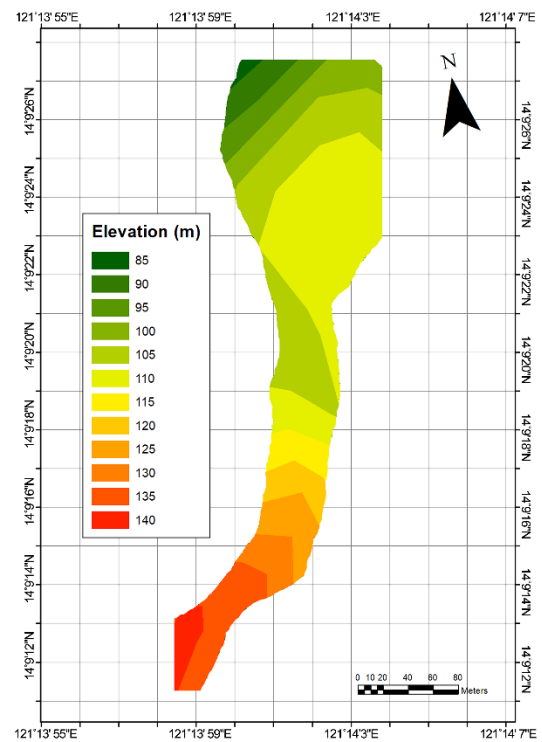
Figure 9. Elevation map of the recreational area of Makiling Botanic Gardens.

Regarding elevations in the study area, the recreational area of MBG exhibits increasing elevation from the entrance (northeast portion of the area) to the *Dipterocarp* area (southern portion of the area) (see Figure 9). The area yielded a maximum elevation of 140 m above mean sea level and a minimum elevation of 85 m above mean sea level, resulting in a maximum slope height of approximately 55 m. Moreover, the immediate changes in elevation in the *Dipterocarp* area and Molawin Creek area (northwest portion of the area) indicate the presence of relatively steep slopes within the said areas. Furthermore, the slope angles within the recreational area range from a minimum angle of 0° to a maximum angle of 20° (Figure 10). This indicates that the highest slope angles of the recreational area are present within the Molawin Creek area (Figure 9). The slope angles were one of the main parameters of interest to determine the static Factor of Safety (FS) values within the recreational area. Lastly, the shear strength of the Macolod clay within the recreational area of MBG ranges from a minimum shear strength of 12 kPa to a maximum shear strength of 26 kPa (Figure 11).

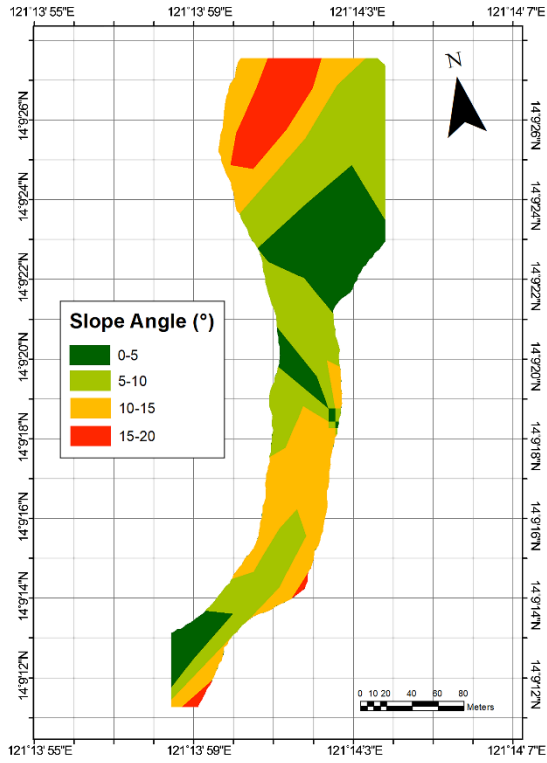
Figure 10. Slope angle map of the recreational area of Makiling Botanic Gardens.

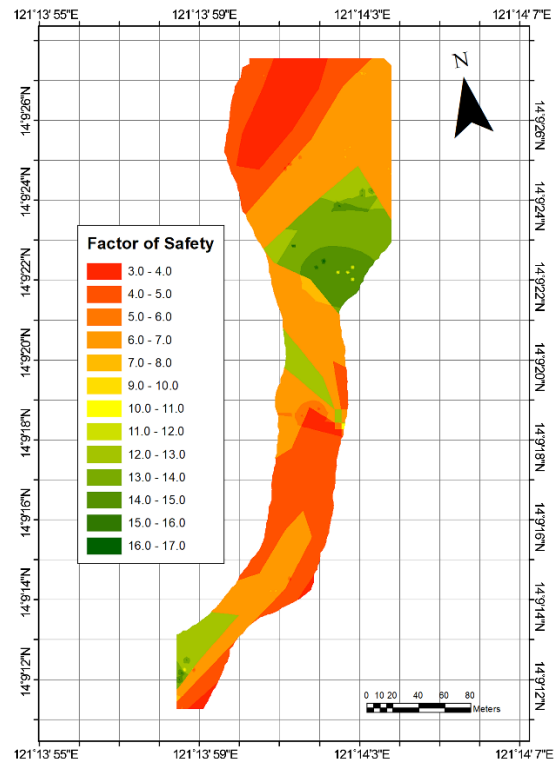
Figure 12. Factor of safety map for the recreational area of Makiling Botanic Gardens.

The entirety of the recreational area of MBG has a static FS of more than 1.5, implying that the area has safe and stable slopes on average since all FS values are higher than unity based on Figure 12. These values further indicate that the resisting forces in the soil and slopes are sufficient to resist the shear forces acting within the soil. Additionally, a conservative value of 1.5 for the FS is generally acceptable as the basis for the design of a stable slope (Das 2010). An FS of less than 1.5 or close to unity may imply that the slope is close to failure with additional loads. Moreover, an FS of precisely unity indicates slope failure when the applied load reaches the design load. At the same time, an FS of less than unity indicates slope failure even without the application of loads. Since the FS of the recreational area of MBG yielded a value of more than 1.5, the area is suitable for some infrastructure developments since loading and environmental conditions are not severe (Maria 2016). Specifically, the minimum FS value yielded by the recreational area is around 3.02, in the Molawin Creek area and some portions of the *Dipterocarp* area. The relatively low FS value yields are consistent with the previously observed trends within the same areas. This implies that these areas have relatively very steep slopes (Figure 9) with large slope angles, which are both factors that affect slope stability. A steeper slope or a higher slope angle would result in a decrease in slope stability, which further increases its susceptibility to landslide occurrence due to the increasing effects of gravity as the plane becomes

event of a seismic-induced landslide ranging from 80 mm to 130 mm. While the said areas have stable slopes in terms of static factors (Figure 12), the same areas have unstable slopes in terms of dynamic factors (Figure 13) resulting to significant seismic-induced slope displacement values. These dynamic factors generally consider the stability of the slopes against dynamic forces such as seismic-induced forces. Unfortunately, the Molawin Creek and *Dipterocarp* areas yielded relatively low resistance against these forces. As a result, in the event of an earthquake, the slopes within the Molawin Creek and *Dipterocarp* areas are high and likely to be significantly and progressively displaced which could lead to slope failures and seismic-induced landslides.

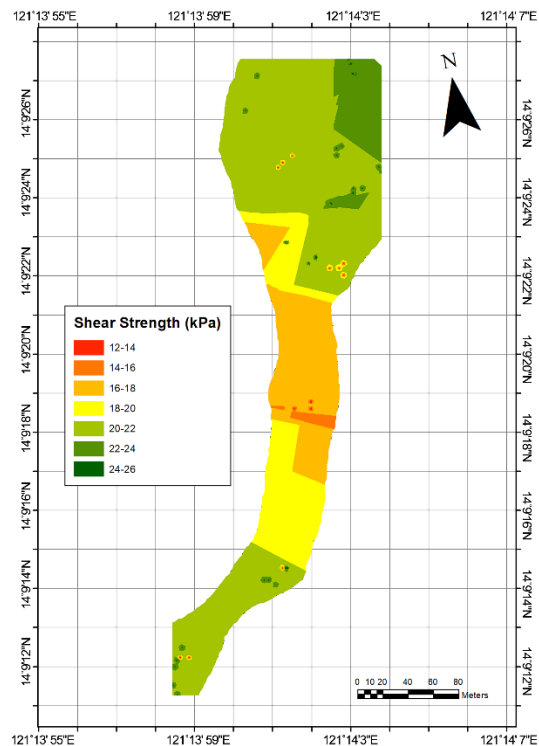
Figure 11. Shear strength map of the recreational area of Makiling Botanic Gardens.

Relatively, low shear strength is observed in the central portion of the area, while relatively high shear strength is observed in the northern and southern portions of the area. Like the slope angles, the shear strength values served as one of the main parameters of interest to determine the static FS values within the recreational area. Additionally, due to the lack of Standard Penetration Test (SPT) data within the recreational area of MBG, the shear strength map served as the basis for the site classification of the

study area. According to Atkinson (2008), shear strength values of less than 20 kPa and between 20 kPa and 40 kPa indicate the presence of very soft soil and soft soil, respectively. Based on Table 4, site classification E corresponds to an area with a soft soil profile. Thus, the 3.5 ha recreational area of MBG has a site classification of E due to soft soil (Figure 11). The site classification served as a basis for adjusting seismic parameters in the seismic-induced landslide hazard analysis of the said area.

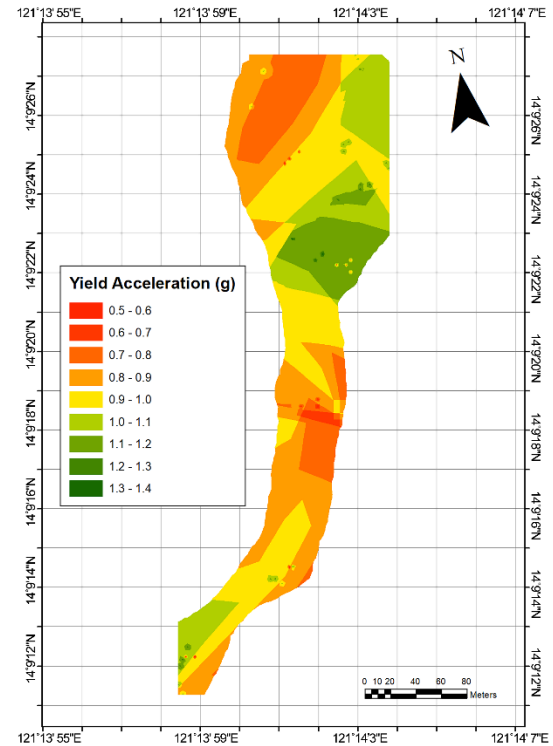
Figure 13. Yield acceleration map of recreational area of Makiling Botanic Gardens.

Through ArcGIS, all the previously generated maps were combined and intersected. Fishnets were established using 10 m by 10 m grids, resulting in a generated map with 1,388 individual cells with their own unique sets of attributes. The static FS of each of the 1,388 cells was determined using Equation 1 and added as an attribute, resulting in an FS map shown in Figure 12. After determining the FS values at each cell and using Equation 2, the yield acceleration values for each of the 1,388 cells of the plotted recreational area of MBG were determined and added as an attribute, resulting in a yield acceleration map (see Figure 13).

Meanwhile, the entirety of the recreational area has a yield acceleration value ranging from 0.5 g to 1.4 g (Figure 13). The obtained value indicates that a minimum pseudo-static acceleration equal to the acceleration due to gravity multiplied by a factor of 0.5 must be induced to cause slope instability and landslide occurrence in some portions of the recreational area. Furthermore, the Molawin Creek and *Dipterocarp* areas yielded relatively low yield acceleration values, ranging only from 0.5 g to 0.8 g (Figure 12). These areas also yielded the lowest FS values, which served as the main factor for the differences in yield acceleration values at different areas of the recreational area of MBG. Based on the peak ground acceleration (PGA) maps of Peñarubia et al. (2020), the PGA for the area of Los Baños, Laguna, ranges from 0.3 g to 0.5 g considering a return period of 475 years. Following the American Society of Civil Engineers (ASCE) Section 7-05 and consideration of the site classification (E) of the recreational area, an amplification factor was applied to the PGA values, resulting in an amplified PGA for the recreational area of MBG, ranging from 0.70 g to 0.85 g . As a result, in the event of an earthquake, slope instabilities and

movements are highly likely to occur in the Molawin Creek area and *Dipterocarp* area since their respective yield acceleration values are less than or within the range of the amplified PGA for the recreational area of MBG.

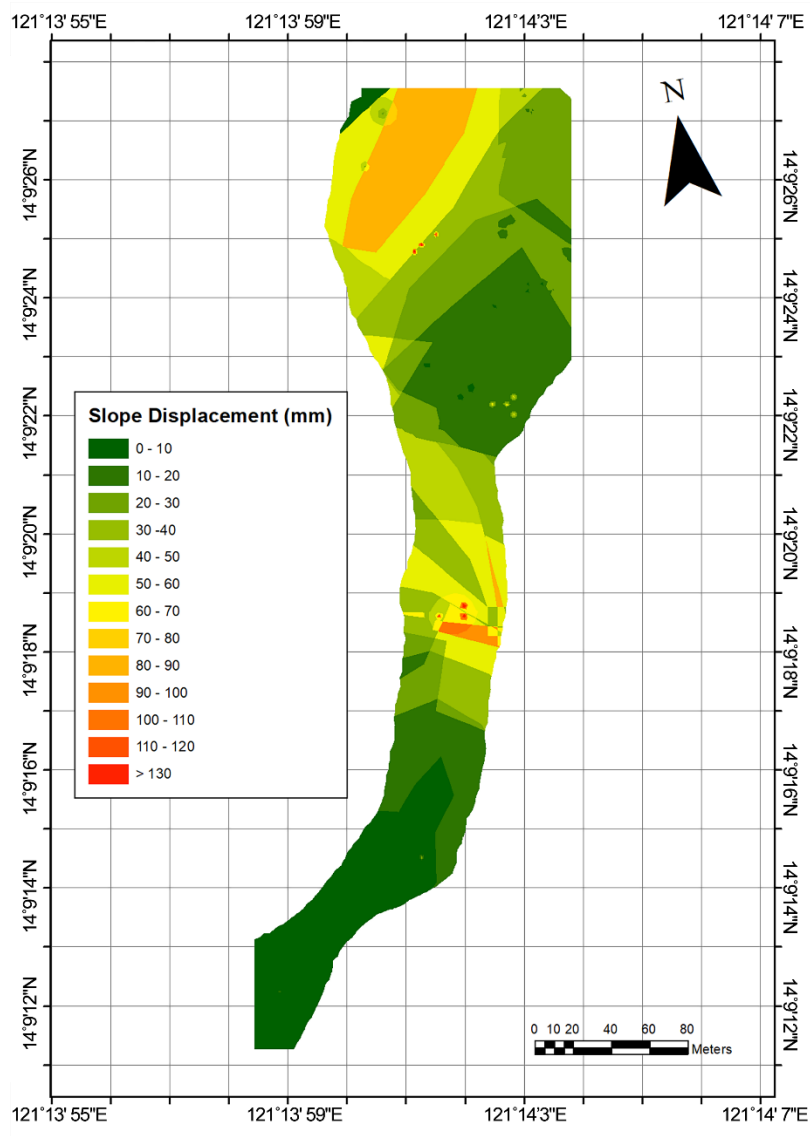
Figure 14. Slope displacement map of the recreational area of Makiling Botanic Gardens.

For the determination of projected slope displacements due to seismic-induced landslides, the peak ground acceleration (PGA) and spectral acceleration (SA), with a 475-year return period, for the recreational area of MBG were determined and considered. Considering the amplified PGA for the recreational area, a conservative value of $0.85g$ was considered for the PGA of the said area. Meanwhile, using the generated site-specific spectral acceleration design response spectrum for the same area, each of the 1,388 cells of the study area was assigned a spectral acceleration value based on the fundamental period computed for each cell using Equation 4. Finally, using Equation 3, the slope displacement for each cell was determined and assigned as an attribute, resulting in the slope displacement map (see Figure 14).

Some portions of the recreational area have minimal projected slope displacements in the event of a seismic-induced landslide ranging only from 0 mm to 10 mm (Figure 14). However, some portions of the recreational area have large and significant slope displacements in the event of a seismic-induced landslide (Figures 12 and 13). Specifically, the Molawin Creek area and *Dipterocarp* area yielded the relatively highest projected slope displacements in the
